# Coastal processes schools case study: Slapton Sands

Working for the South West Regional Coastal Monitoring Programme, the Plymouth Coastal Observatory measures and records detailed information on more than 2,000km of England's coastline from the Severn Estuary to Portland Bill

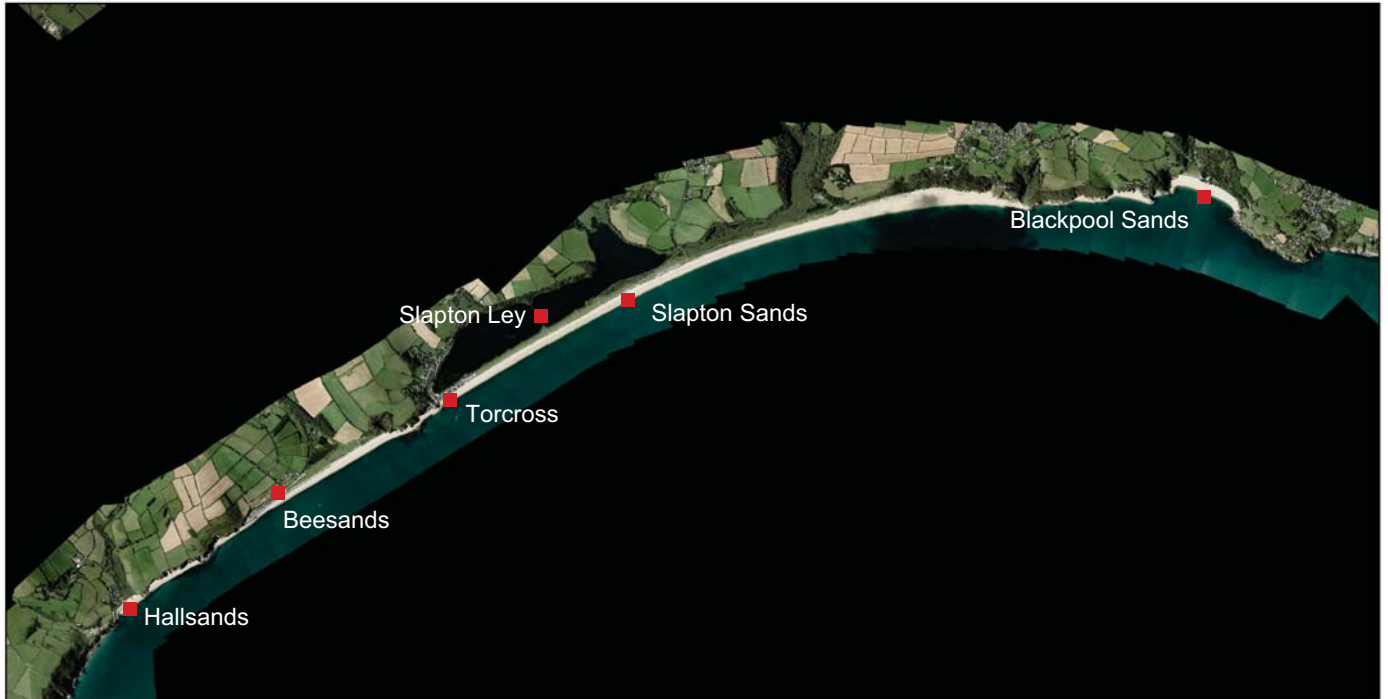
1 Slapton Sands is a shingle barrier beach, which along with Blackpool Sands, Beesands and Hallsands, makes up Start Bay on the south coast of Devon (above). The village of Torcross is located at the southern end of the beach and Slapton Ley, a large lake and nature reserve, is located behind the beach and road. From looking at the wave rose (below), which is the most common direction for waves to approach Slapton from and what is the most common height of these waves?

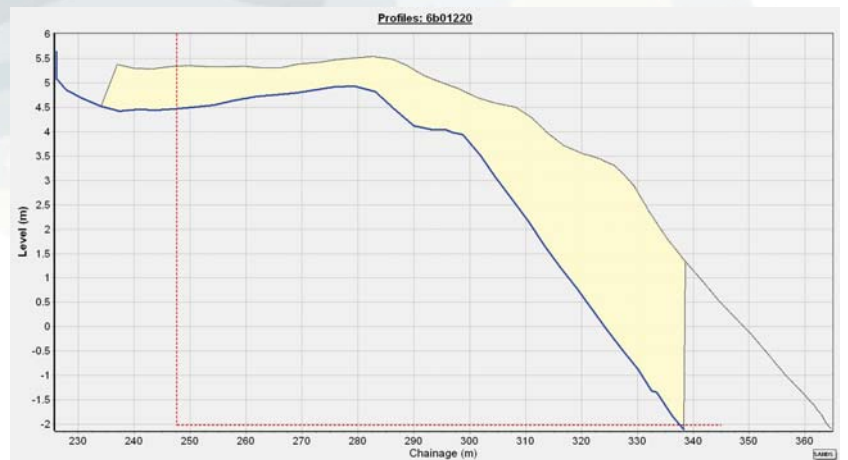
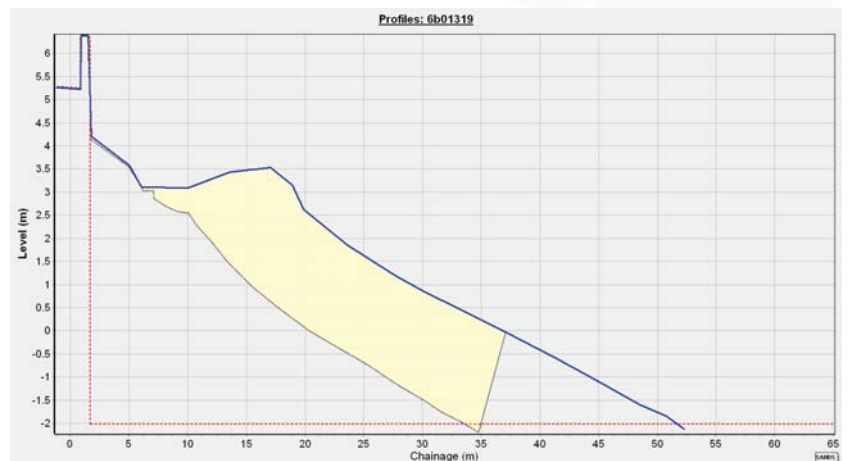
--- 2016 --- 2007

The profile charts on the previous page show how the beach shape changed between 2007 and 2016. What is the greatest amount by which the beach has changed height and how has the lowest point on the beach changed position horizontally?

This first figure is a difference model which shows the change in beach height over a certain period. Red indicates erosion (where material has been lost) and blue indicates accretion (where material has been gained). Does the difference model, along with the profile charts below (which show the cross-sectional area of the beach), confirm your answer?

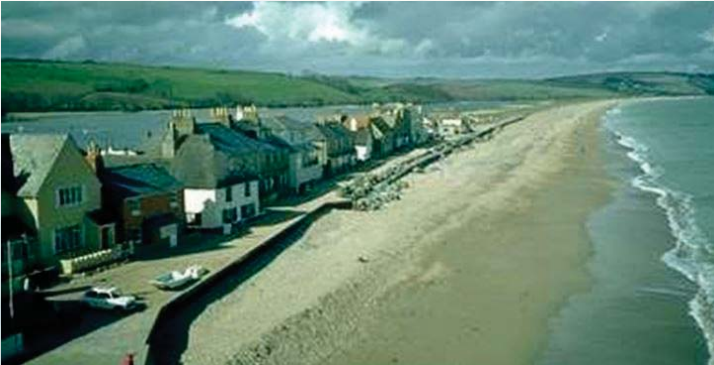
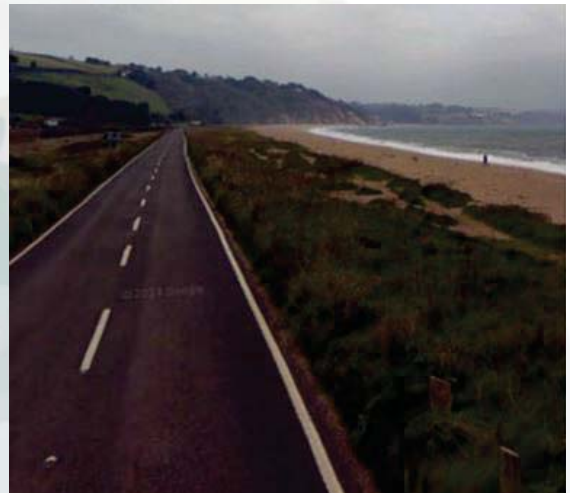
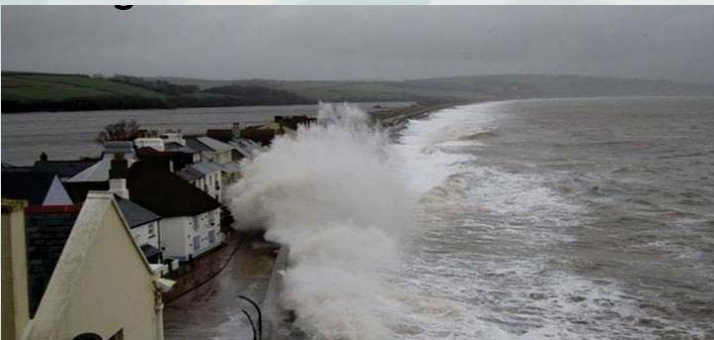
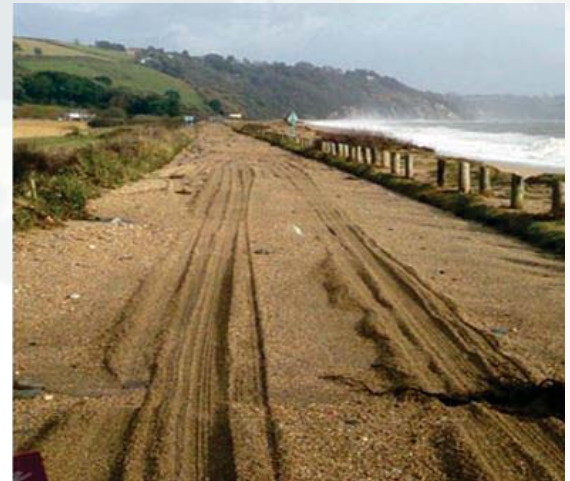
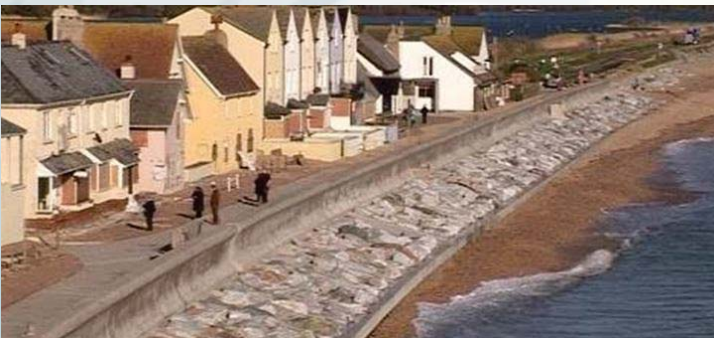
The images above show some of the impacts of the storms which struck the southwest in January and February 2014. Notice how the bottom of the seawall in front of Torcross becomes uncovered whilst further north the road gets covered in material. Compare the wave rose on the next page (which shows the storm conditions) with the previous one (which shows the average conditions), how do the heights of the waves differ?

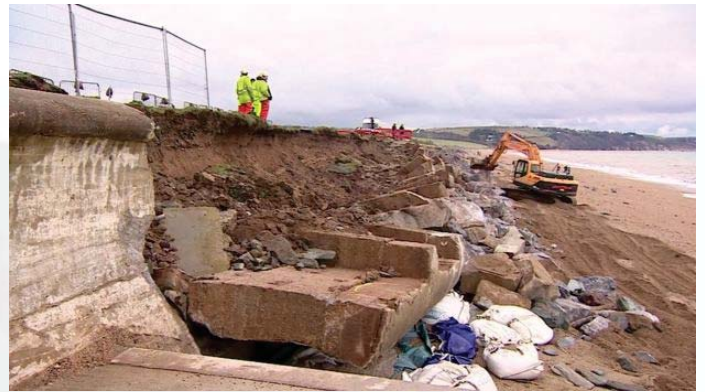
Collapse of the seawall at Torcross

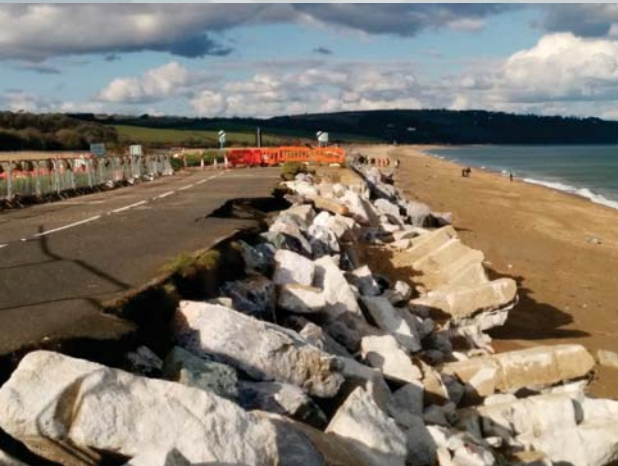
Road closures are becoming more regular at Slapton
